New Hampshire Volunteer Lake Assessment Program

2003 Biennial Report for Tolman Pond Nelson

NHDES Water Division Watershed Management Bureau 29 Hazen Drive Concord, NH 03301

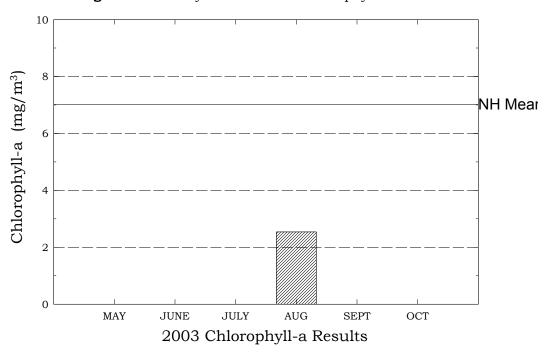
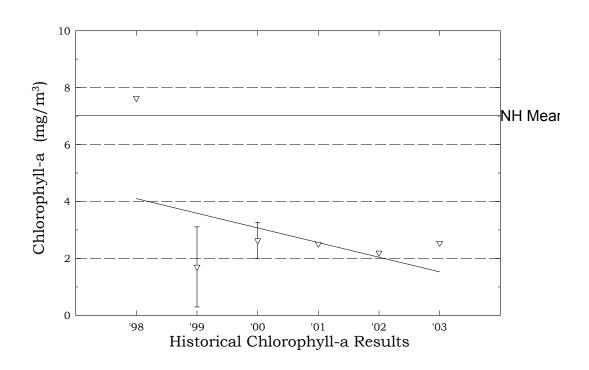
Figure 1. Monthly and Historical Chlorophyll-a Results

Figure 1 and Table 1: The graphs in Figure 1 (Appendix A) show the historical and current year chlorophyll-a concentration in the water column. Table 1 (Appendix B) lists the maximum, minimum, and mean concentration for each sampling season that the pond has been monitored through the program.

The current year data (the top graph) show that the chlorophyll-a concentration in August was *much less than* the state mean.

The historical data (the bottom graph) show that the 2003 chlorophyll-a mean is *less than* the state mean.

Overall, visual inspection of the historical data trend line (the bottom graph) shows **a** relatively stable in-lake chlorophyll-a trend, meaning that the concentration has remained approximately the same since monitoring began. After 10 consecutive years of sample collection, we will be able to conduct a statistical analysis of the historic data to objectively determine if there has been a significant change in the annual mean chlorophyll-a concentration since monitoring began.

While algae are naturally present in all lakes/ponds, an excessive or increasing amount of any type is not welcomed. In freshwater lakes/ponds, phosphorus is the nutrient that algae depend upon for growth. Algal concentrations may increase with an increase in nonpoint sources of phosphorus loading from the watershed, or inlake sources of phosphorus loading (such as phosphorus releases from the sediments). Therefore, it is extremely important for volunteer monitors to continually educate residents about how activities within the watershed can affect phosphorus loading and lake/pond quality.

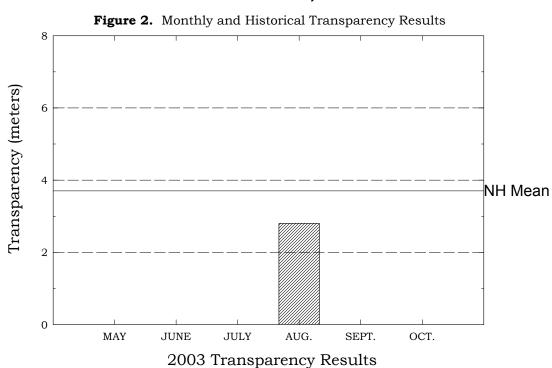
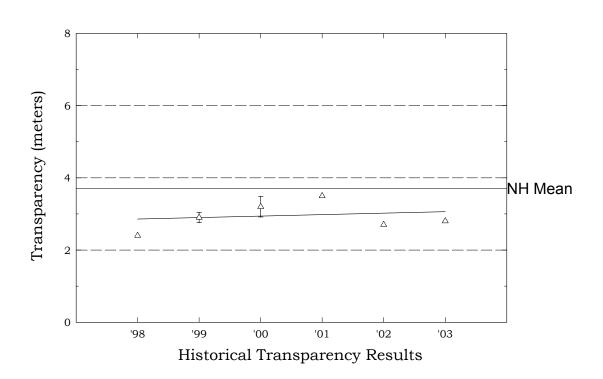
Figure 2 and Table 3: The graphs in Figure 2 (Appendix A) show historical and current year data for pond transparency. Table 3 (Appendix B) lists the maximum, minimum and mean transparency data for each sampling season that the pond has been monitored through the program.

The current year data (the top graph) show that the in-lake transparency in August was *less than* the state mean.

The historical data (the bottom graph) show that the 2003 mean transparency is *less than* the state mean.

Overall, visual inspection of the historical data trend line (the bottom graph) shows **a stable** trend for in-lake transparency, meaning that the transparency has **remained approximately the same** since monitoring began. After 10 consecutive years of sample collection, we will be able to conduct a statistical analysis of the historic data to objectively determine if there has been a significant change in the annual mean transparency since monitoring began.

Typically, high intensity rainfall causes erosion of sediments into lakes/ponds and streams, thus decreasing clarity. Efforts should continually be made to stabilize stream banks, pond shorelines, disturbed soils within the watershed, and especially dirt roads located immediately adjacent to the edge of tributaries and the pond. Guides to Best Management Practices designed to reduce, and possibly even eliminate, nonpoint source pollutants, such as sediment loading, are available from DES upon request.

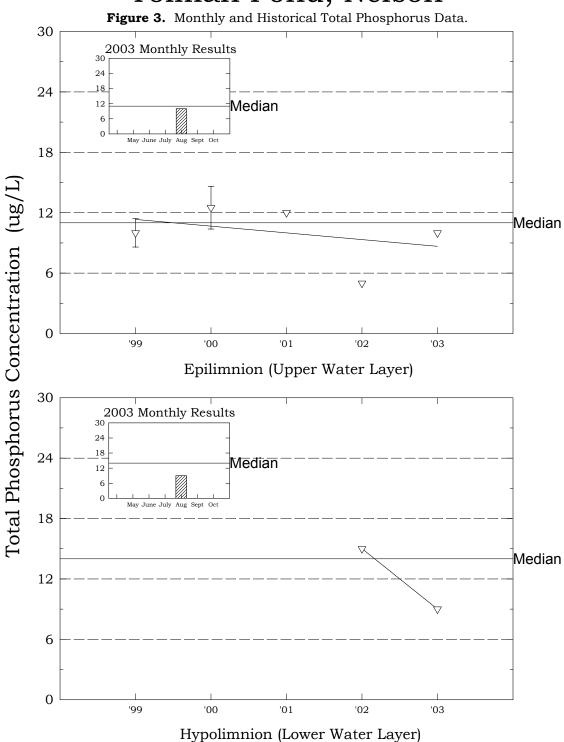
Figure 3 and Table 8: The graphs in Figure 3 (Appendix A) show the amounts of phosphorus in the epilimnion (the upper layer) and the hypolimnion (the lower layer); the inset graphs show current year data. Table 8 (Appendix B) lists the annual maximum, minimum, and median concentration for each deep spot layer and each tributary since the lake/pond has joined the program.

The current year data for the epilimnion (the top inset graph) show that the phosphorus concentration in August was **approximately equal to** the state median.

The historical data show that the 2003 mean epilimnetic phosphorus concentration is *approximately equal to* the state median.

The current year data for the hypolimnion (the bottom inset graph) show that the phosphorus concentration in August was *less than* the state median.

The historical data show that the 2003 mean hypolimnetic phosphorus concentration is *less than* the state median.

Overall, visual inspection of the historical data trend line for the epilimnion show **a relatively stable** phosphorus trend, which means that the concentration has **remained approximately the same** in the epilimnion since monitoring began.

Overall, visual inspection of the limited historical data for the hypolimnion shows **a** decreasing phosphorus trend, which means that the concentration has **improved** in the hypolimnion since monitoring began.

One of the most important approaches to reducing phosphorus loading to a waterbody is to continually educate watershed residents about its sources and how excessive amounts can adversely impact the ecology and value of lakes and ponds. Phosphorus sources within a lake or pond's watershed typically include septic systems, animal waste, lawn fertilizer, road and construction erosion, and natural wetlands.
